Peter Scott Field Studies Centre

Monthly Environmental Impact Monitoring Report

August 2020

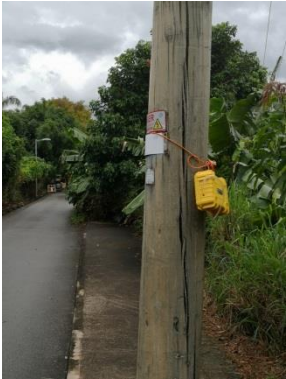
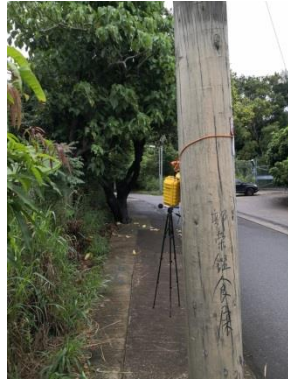
AQMP1

Photographic Record of Air Quality and Noise Monitoring Locations
